**Waterloo Region
District School Board**

Surplus Property Disposition

Three Bridges Public School

**Tender No.: 6715-KP-16
Issued: February 4, 2016**

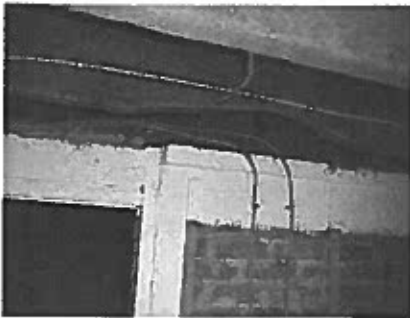
Cracked and broken beams, joists and posts were observed during the assessment. One main beam has been metal strapped in an attempt to limit further deterioration and steel posts, without foundations, have been added for additional floor support.

Split beam with metal strapping

It is recommended, that repairs as directed by the study be undertaken. The budget cost provided in this event is an estimate, which should be confirmed by the study.

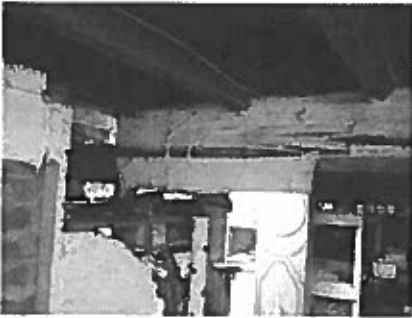
Mar 2012 Split beam with metal strapping

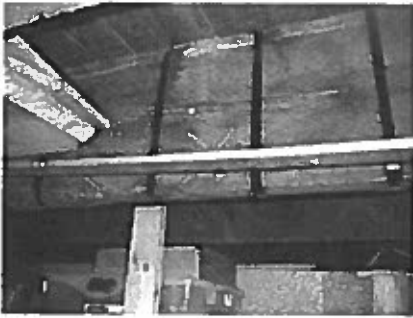
Mar 2012 Split beam with metal strapping

A study is recommended in order to determine the condition of the building structural elements. Deferral of the study could result in further deterioration, which may affect the stability of the building structure.

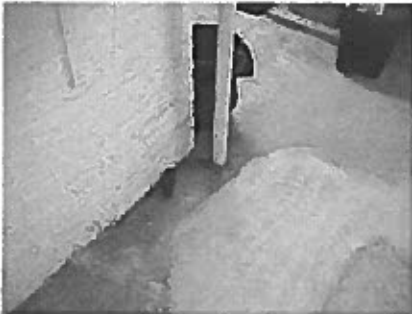
Mar 2012 Added steel support jack resting on basement floor slab (no foundation)

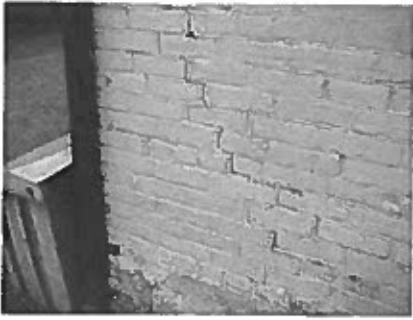
Cracks have developed in the external walls of the original school building.

Mar 2012 Deteriorating Brickwork on original school

Deteriorated mortar joints along with chipped brick exteriors were indicated on the exterior walls. Replacement of deficient brick and repointing of the deficient exterior wall is recommended.

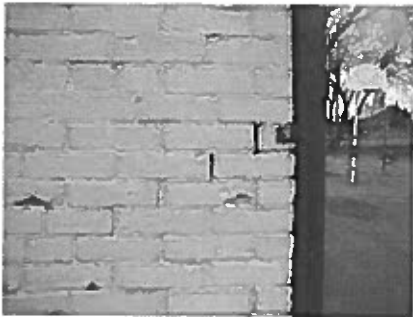
Mar 2012 Deteriorating Brickwork on original school

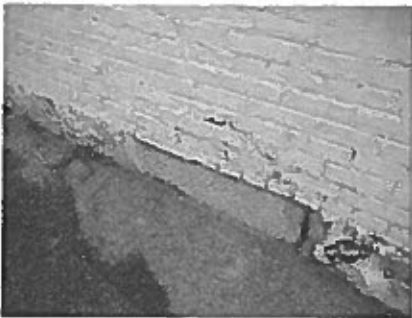
Mar 2012 Deteriorating Brickwork on original school

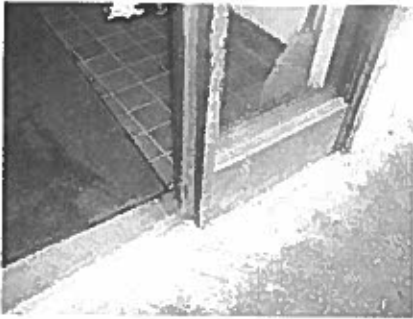
Mar 2012 Corroding hollow metal door frame

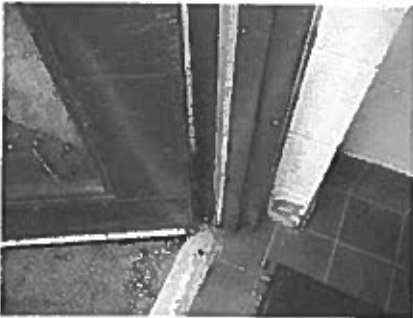
Mar 2012 Corroding hollow metal door frame

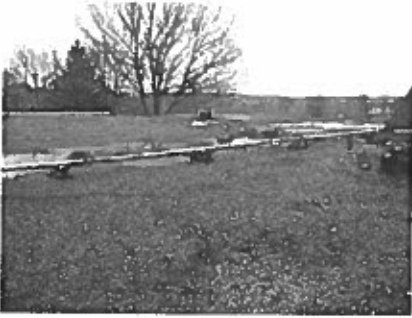
Mar 2012 Ponding on the 1953 roof

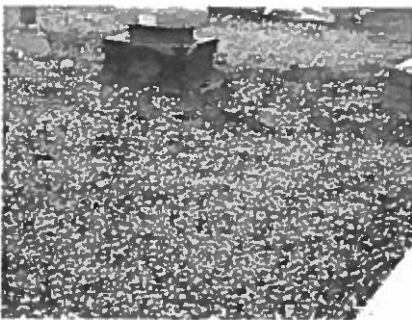
Mar 2012 Vegetation growth on 1981 roof

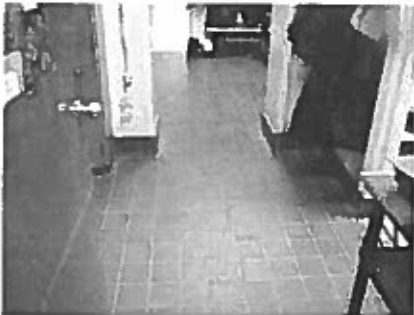
Mar 2012 Damaged door o classroom

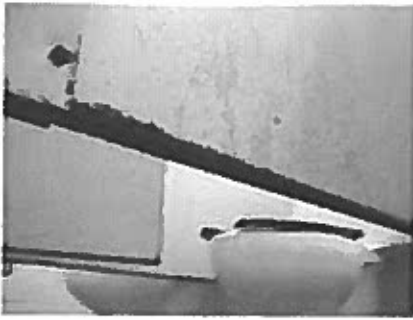
Mar 2012 Corrosion on base of toilets partitions

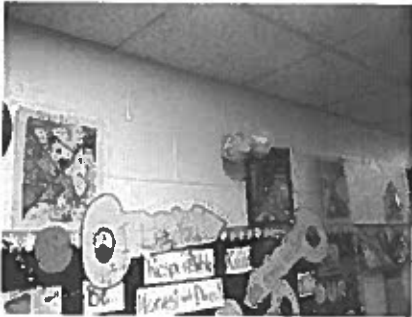
Mar 2012 Stained ceiling tiles in corridor

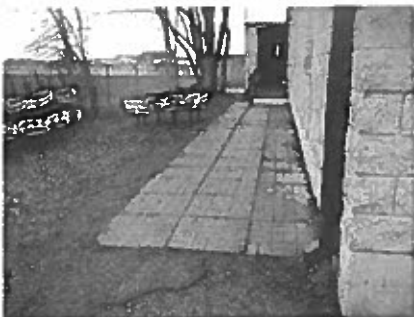
Mar 2012 Uneven paved walkway

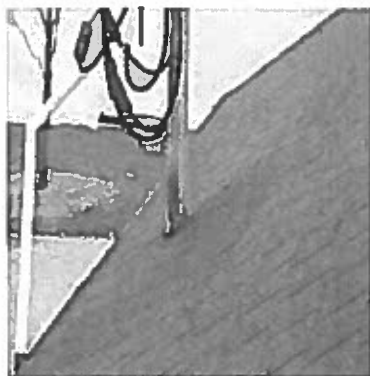
Type Of Defect	Severity	Quantity
Sealant Deficiency	Moderate	1

It was observed that the sealant has deteriorated.

Budget Year	Activity Type	Action Item ?	Allocation	Urgency	Quotation \$
2009	Maintenance	Yes	Maintenance	Moderate	\$200
Remove and replace sealant.					
2019	Replacement	No	Capital	Moderate	\$13,120
We recommend complete roof replacement. Remove all roofing materials down to the deck and then install a new roofing system.					
					\$13,320

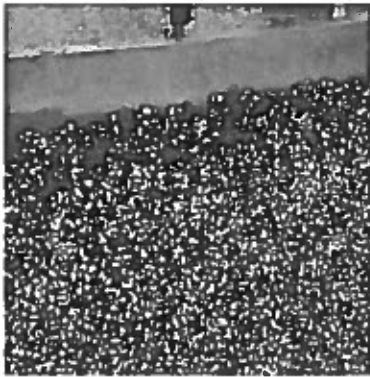
Type Of Defect	Severity	Quantity
Blueberries	Minor	1

Small spherical detached pieces of asphalt. They are formed when water penetrates the top coat of asphalt; freeze-thaw cycling breaks pieces of the flood-coating loose, and the wind blows these pieces around until they are eroded into a spherical shape. Subsequently, water flow causes them to accumulate in low spots on the roof. The occurrence of blueberries indicates that the roof system has less than the original waterproofing top pour. This may adversely effect the long-term performance of the roof.

Budget Year	Activity Type	Action Item ?	Allocation	Urgency	Quotation \$
2009	Maintenance	Yes	Maintenance	Moderate	\$200
Remove and replace damaged sheet metal flashing.					
2010	Replacement	Yes	Capital	Moderate	\$850
We recommend complete roof replacement. Remove all roofing materials down to the deck and then install a new roofing system.					
					\$1,050

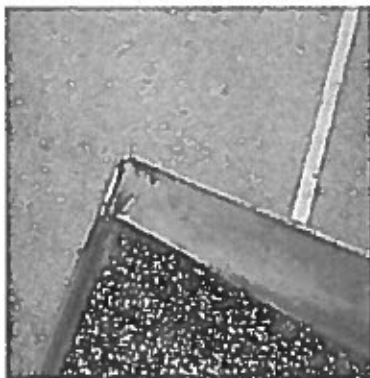
Type Of Defect	Severity	Quantity
Flashings	Moderate	1

It was observed that the flashing was loose and damaged.

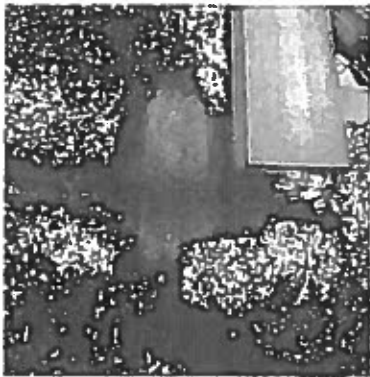
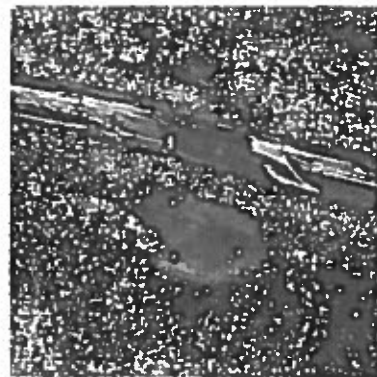
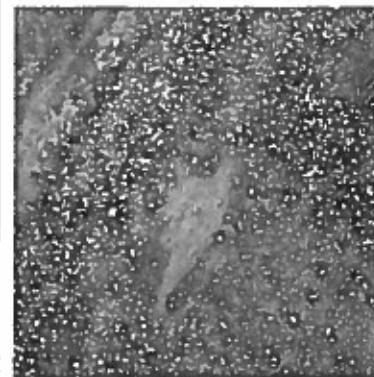
Type Of Defect	Severity	Quantity
Repairs	Moderate	1

Repairs to the roof membrane were observed indicating previous roof problems.

Budget Year	Activity Type	Action Item ?	Allocation	Urgency	Quotation \$
2009	Maintenance	Yes	Maintenance	Moderate	\$1,100
Remove and replace sealant at top of flashing detail. Repair areas of bare felts.					
2010	Replacement	Yes	Capital	Moderate	\$23,749
We recommend complete roof replacement. Remove all roofing materials down to the deck and then install a new roofing system.					
					\$24,849

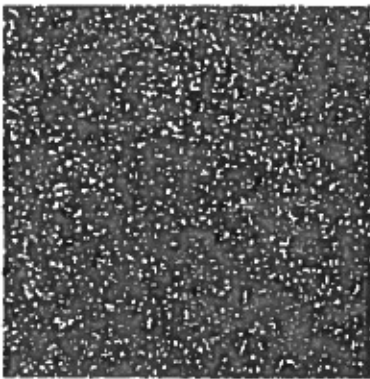
Type Of Defect	Severity	Quantity
Blueberries	Minor	1

Small spherical detached pieces of asphalt. They are formed when water penetrates the top coat of asphalt, freeze-thaw cycling breaks pieces of the flood-coating loose, and the wind blows these pieces around until they are eroded into a spherical shape. Subsequently, water flow causes them to accumulate in low spots on the roof. The occurrence of blueberries indicates that the roof system has less than the original waterproofing top pour. This may adversely effect the long-term performance of the roof.

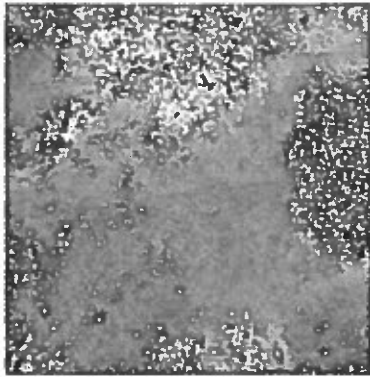
Type Of Defect	Severity	Quantity
Bare felts	Moderate	1

Roofing felts are fabrics manufactured by the interlocking of fibers through a combination of mechanical work, moisture, and heat without spinning, weaving or knitting. Roofing felts are manufactured from vegetable fibers, asbestos fibers or glass fibers. They are either impregnated or coated with bitumen. Their primary function is to provide strength in a multi-ply roof system. They have very poor ultraviolet light resistance and waterproofing ability. They are usually waterproofed with surface bitumen and an ultraviolet light resistant aggregate or are coated. When felts in a roof system become exposed to moisture they may progressively lose both their minimal waterproofing integrity and their strength can become severely diminished. Organic felts may eventually rot from this moisture attack.

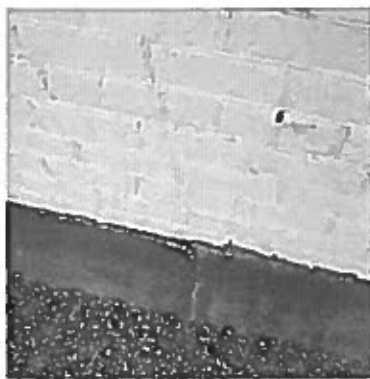
Type Of Defect	Severity	Quantity
Sealant Deficiency	Moderate	1

It was observed that the sealant has deteriorated at the top of flashing detail.

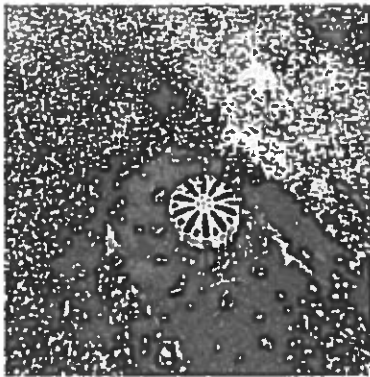
Type Of Defect	Severity	Quantity
Debris	Moderate	1

Any foreign objects on the surface of the roof. These foreign objects could include vegetation such as dead leaves and man made objects such as broken glass, nails, etc.
 The build up of roof top debris frequently impedes positive drainage, clogs drains and results in the development of ponding water conditions. In it's extreme, this could result in roof collapse
 Sharp foreign objects can puncture a roof membrane if stepped upon , resulting in wet insulation, roof leaks and interior damage.

Budget Year	Activity Type	Action Item ?	Allocation	Urgency	Quotation \$
2009	Maintenance	Yes	Maintenance	Moderate	\$1,600
Install extruded polystyrene to provide adequate membrane protection under wood walkway. Repair membrane ridging. Install extruded polystyrene to provide adequate membrane protection under the gas blocks. Clean and remove debris from roof area.					
2010	Replacement	Yes	Capital	Moderate	\$66,640
We recommend complete roof replacement. Remove all roofing materials down to the deck and then install a new roofing system.					
					\$68,240

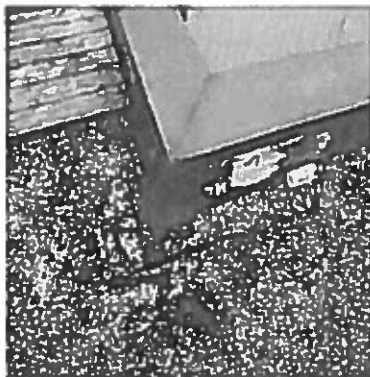
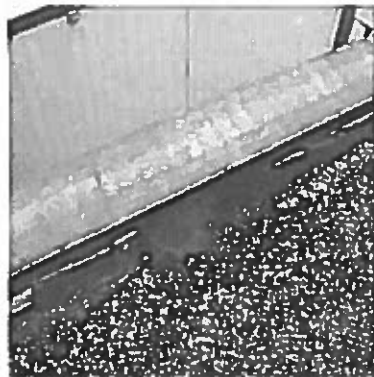
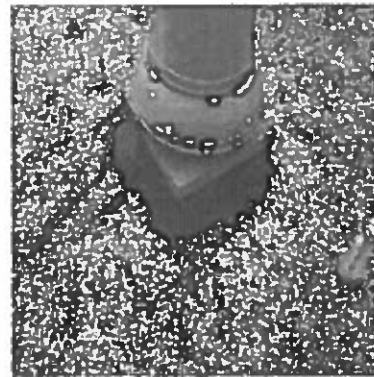
Type Of Defect	Severity	Quantity
Repairs	Moderate	1

Repairs to the roof membrane were observed indicating previous roof problems.

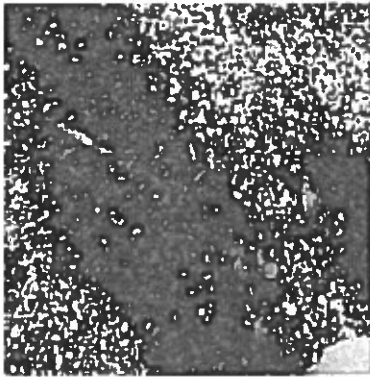
Type Of Defect	Severity	Quantity
Blueberries	Minor	1

Small spherical detached pieces of asphalt. They are formed when water penetrates the top coat of asphalt; freeze-thaw cycling breaks pieces of the flood-coating loose, and the wind blows these pieces around until they are eroded into a spherical shape. Subsequently, water flow causes them to accumulate in low spots on the roof. The occurrence of blueberries indicates that the roof system has less than the original waterproofing top pour. This may adversely effect the long-term performance of the roof.

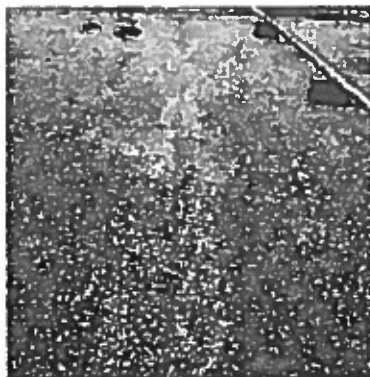
Type Of Defect	Severity	Quantity
Ridging	Moderate	1

A roofing defect characterized by narrow or relatively narrow ripples in a membrane generally along the machine direction for roofing felts and over deck or insulation joints or base sheet edges, and usually less than 1" in height. Ridges are a weakened area of the roof membrane which are prone to splitting. When this happens, major roof leaking and consequential damage can occur.

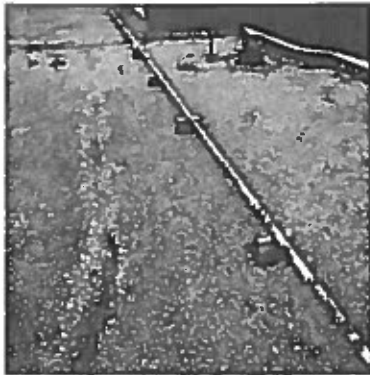
It was observed that there was inadequate membrane protection under the gas blocks.

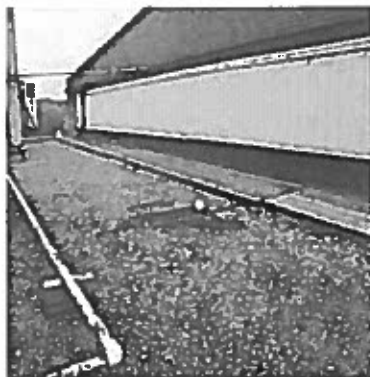
Inadequate Membrane Protection	Moderate	1
--------------------------------	----------	---

It was observed that there was inadequate membrane protection under the walkway.

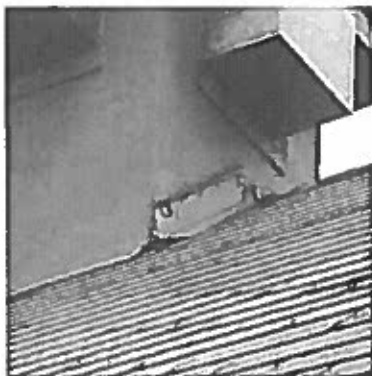
Type Of Defect	Severity	Quantity
Sealant Deficiency	Moderate	1

It was observed that the sealant has deteriorated.

Recommendations Details					
Budget Year	Activity Type	Action Item ?	Allocation	Urgency	Quotation \$
2009	Maintenance	Yes	Maintenance	Moderate	\$200
Remove and replace sealant.					
2015	Replacement	Yes	Capital	Moderate	\$17,840
We recommend complete roof replacement. Remove all roofing materials down to the deck and then install a new roofing system.					\$18,040
