**Waterloo Region
District School Board**

Surplus Property Disposition

Three Bridges Public School

**Tender No.: 6715-KP-16
Issued: February 4, 2016**

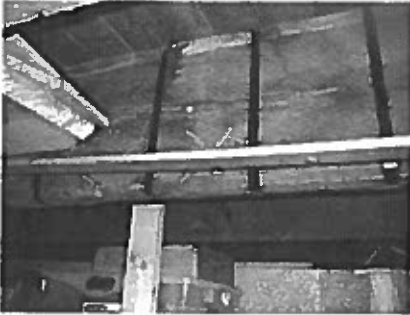
Cracked and broken beams, joists and posts were observed during the assessment. One main beam has been metal strapped in an attempt to limit further deterioration and steel posts, without foundations, have been added for additional floor support.

Split beam with metal strapping

It is recommended, that repairs as directed by the study be undertaken. The budget cost provided in this event is an estimate, which should be confirmed by the study.

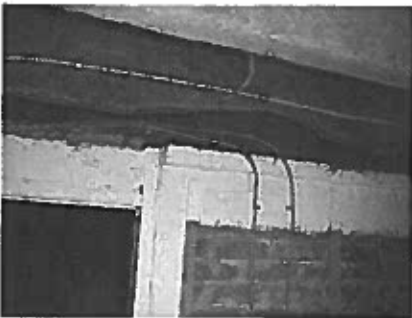
Mar 2012 Split beam with metal strapping

A study is recommended in order to determine the condition of the building structural elements. Deferral of the study could result in further deterioration, which may affect the stability of the building structure.

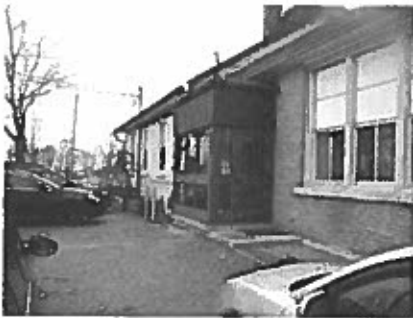
With exposure to the elements, the observed deterioration and corrosion of the hollow metal frames may progress, and weaken the door and door support. It is therefore recommended that planning for complete replacement of the hollow metal frames and door forming the main entrance lobby be made.

Mar 20122 main entrance lobby enclosed by hollow screen frame with door

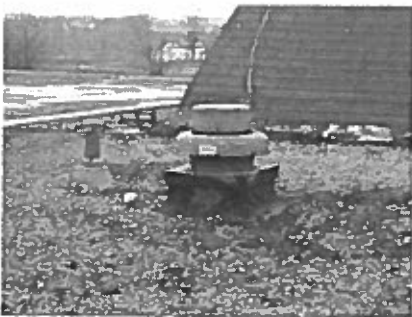
Mar 2012 Vegetation growth on roof

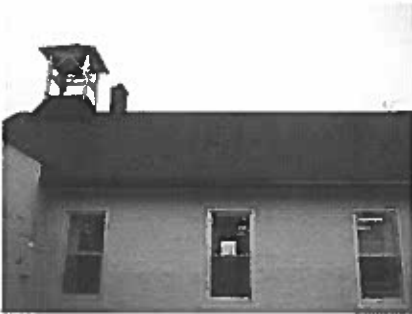
Mar 2012 original school roof

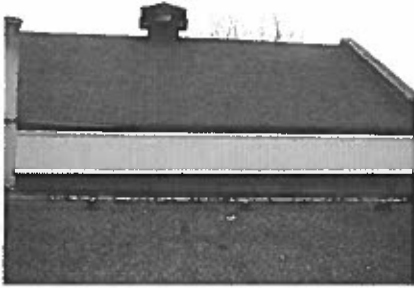
Mar 2012 Gym Roof

Brief Description Replacement - B3010 Roof Coverings 1981 Addition Gym Roof
Estimated Cost \$35,672
Fiscal Event Year 2016
Event Data Origin Board Inspection

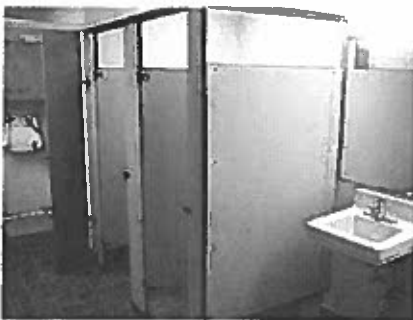
Washroom partitions have surpassed useful service life. Damage and corrosion was observed. Based on age and condition, replacement is recommended.

Mar 2012 Toilet partitions in student washroom

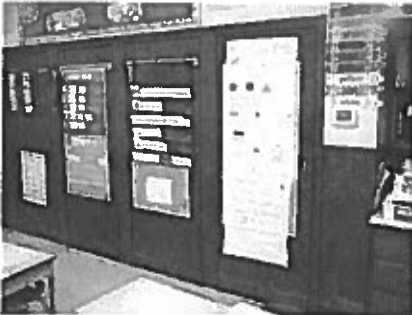
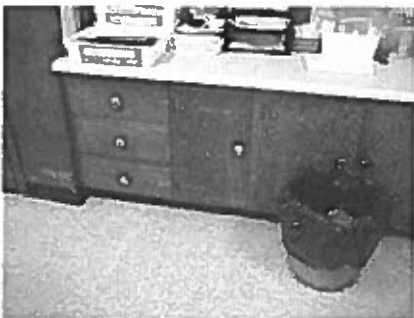
Mar 2012 Classroom millwork

Based on age and observed conditions, replacement of the deteriorated millwork in classrooms 1 and 2 is recommended.

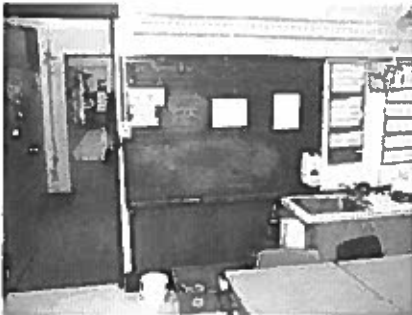
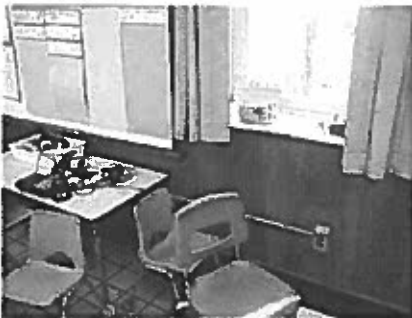
Mar 2012 Wood panelling under blackboard

Mar 2012 Wood panelling

Based on age and observed conditions, repair and refinishing of the wood paneling is recommended.

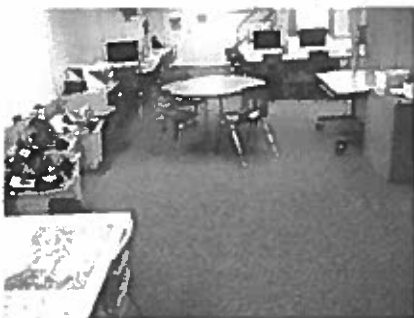
The carpet located throughout the building is subjected to frequent foot traffic. It appears that the carpeting in the building dates back to 1981 and as such, has surpassed the end of its useful life of 10 years. However, in general the basement carpet was in fair condition. Planning for replacement is recommended.

Mar 2012 Carpet in Basement teaching area

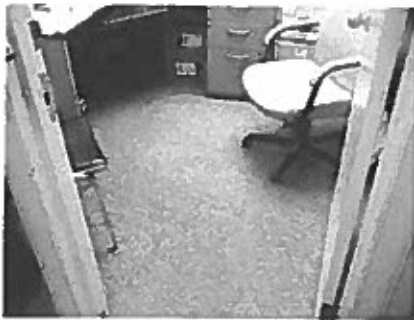
Some stained, discolored and worn sections of carpeting was observed, in the principals office. Replacement is recommended

Mar 2012 Carpet in Principals office

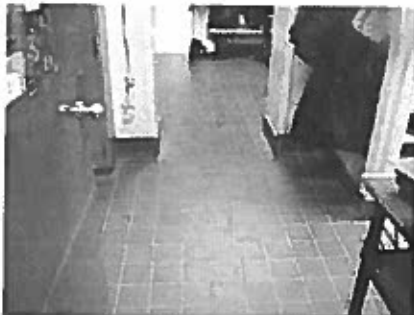
Mar 2012 Quarry Tiles in Main corridor, and washrooms

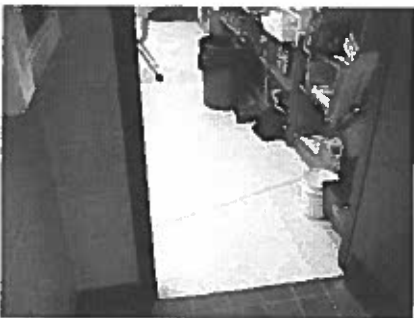
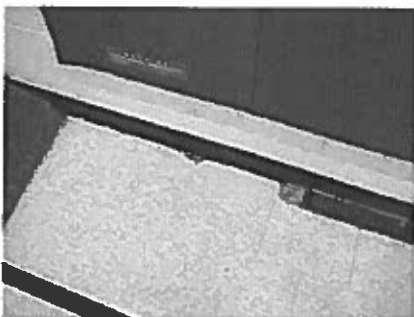
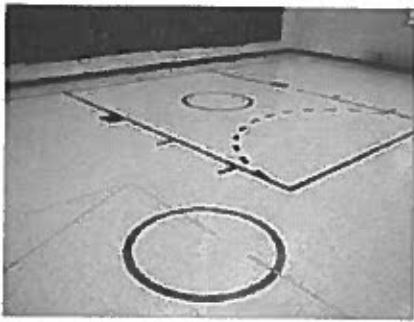
The majority of the vinyl floor tiles were installed at the time of addition 2 construction in 1981. As result age, has surpassed its theoretical useful life of 20 years. Worn surfaces of the vinyl floor tiles were noted. Based on age and condition, replacement of the vinyl floor tiles is anticipated.

Mar 2012 VAT in classroom

Mar 2012 VAT in Gymnasium

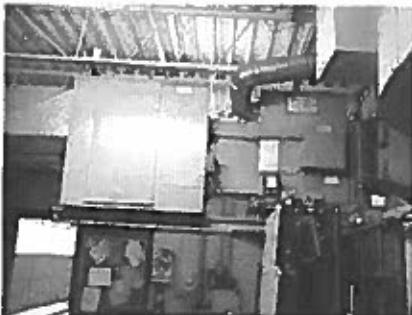
mar 2012 Furnace heating rooms in the 1981 addition

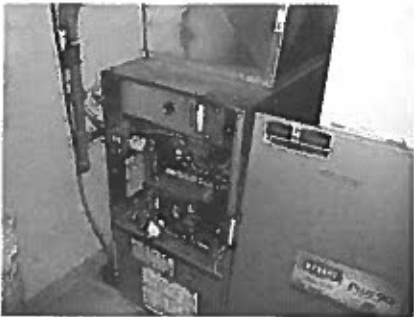
Mar 2015 Furnace heating the gymnasium

Brief Description	Replacement - D302003 Furnaces - Gymnasium
Estimated Cost	\$7,488
Fiscal Event Year	2020
Event Data Origin	Board Inspection

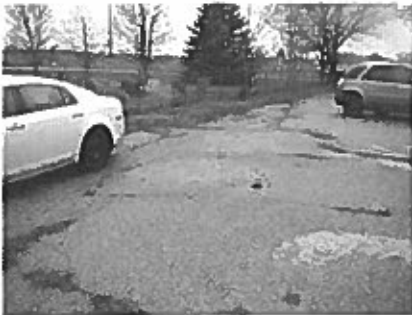
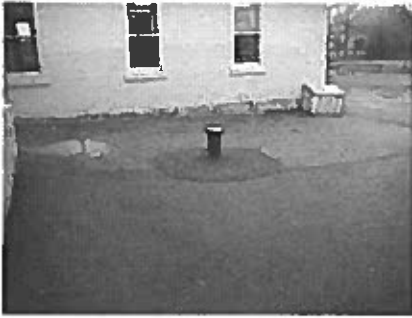
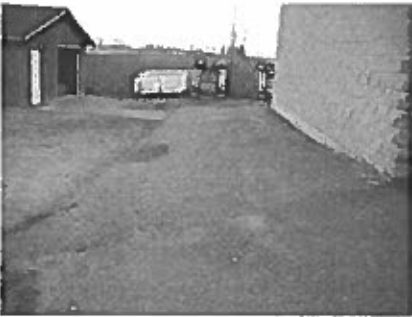
Mar 2012 Asphalt paving in south east corner

Mar 2012 Paving in general play area

Mar 2012 Paving on north side of gymnasium

Further deterioration is anticipated, especially at the asphalt paved area edge. Reconstruction of the deteriorated sections is required in order minimize pothole development. Areas recommended for repair are, the south east corners adjacent to the portable; section on the north side by the gymnasium wall and a section in the play area, for a total area of approximately 3,000 sq.
